## **AVIATION INVESTIGATION REPORT**

**A07P0295**

### **HOT AIR BALLOON ACCIDENT**

**SRP ADVENTURE TOURS  
AEROSTAR S77A (HOT AIR BALLOON), C-GTRU  
SURREY, BRITISH COLUMBIA  
24 AUGUST 2007**

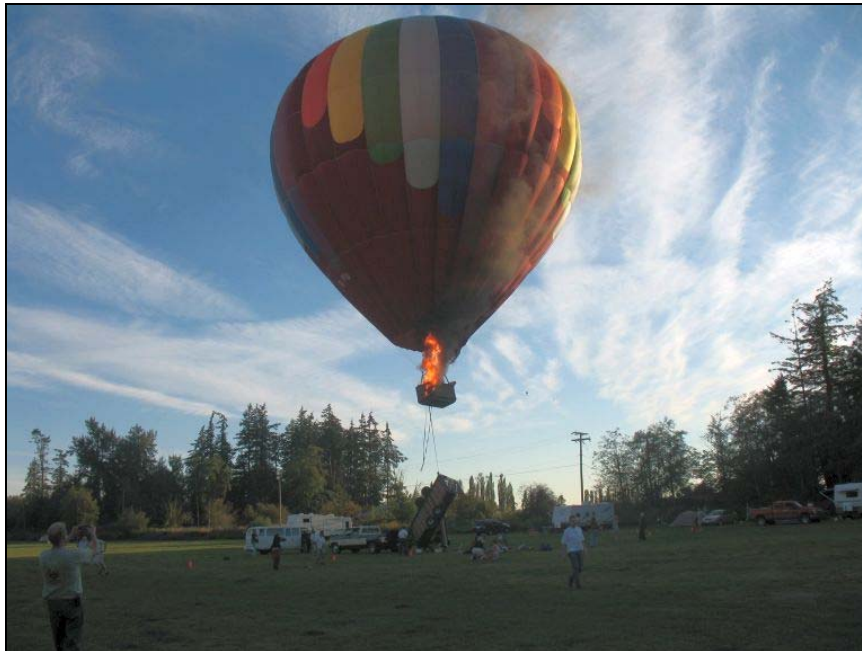
As passengers began to evacuate, the basket began to rise, forcing people to jump from a considerable height. The basket rose to a height of approximately 30 feet, forcing the trailer off the ground. As people continued to jump, some struck the trailer sustaining more serious injuries. The strap was made of a synthetic material that was susceptible to heat damage and it failed, releasing the balloon with two passengers still on board. The balloon climbed and drifted to the north. As the fire progressed, the number 2 cylinder fell from the basket. The balloon envelope collapsed and the burning wreckage descended into a residential trailer park. The two passengers remaining in the basket were fatally injured. Three mobile homes and some vehicles were destroyed.

**Photo 1.** Balloon lifting trailer

6. The strap securing the balloon to the trailer was made of a synthetic material which was susceptible to heat damage and failed in tensile overstress, releasing the balloon with two passengers still onboard.

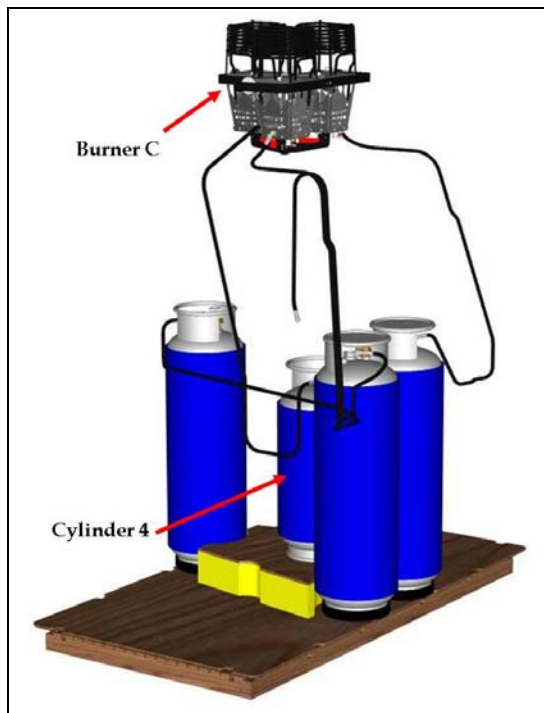
The balloon was originally manufactured with two burners and three 23-gallon capacity propane cylinders installed in the basket. The pilot/owner had replaced the two burners with a three-burner installation which was approved by the manufacturer as part of the type design of the aircraft. He had also installed a fourth cylinder, of 15-gallon capacity, in the basket. This modification was not approved by the manufacturer as part of the type design, nor was it approved by TC. No documentation was produced by the operator to show that this installation was performed or signed-off by an aircraft maintenance engineer (AME). The pilot had instituted the practice of using an auxiliary 10-gallon portable cylinder for initial filling of the envelope with hot air. It was not installed, but placed in the basket for the hot inflation, and removed when its propane was exhausted. The manufacturer was not aware of this practice.

**Figure 1.** S77A modified configuration

3. Modification of the balloon from the manufacturer's configuration by the addition of cylinder number 4 and the use of an additional auxiliary cylinder (number 5) for initial envelope hot inflation contributed to the likelihood of hose/valve discontinuity because of extra wear and handling.

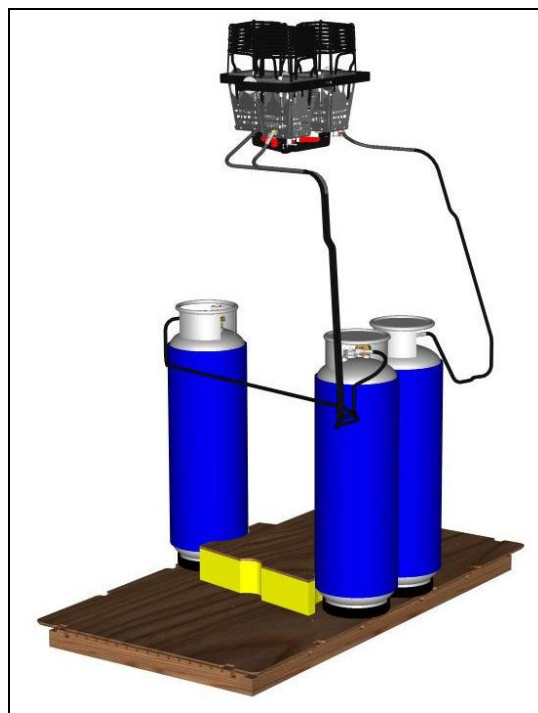
**Figure 2.** S77A manufacturer's three-burner configuration
